Manhole Inspection Summary

Manhole # S23MM_019MH

Insp Date: **7/5/07 10:16 AM**

Location Address: **1218 MCCULLOH ST**

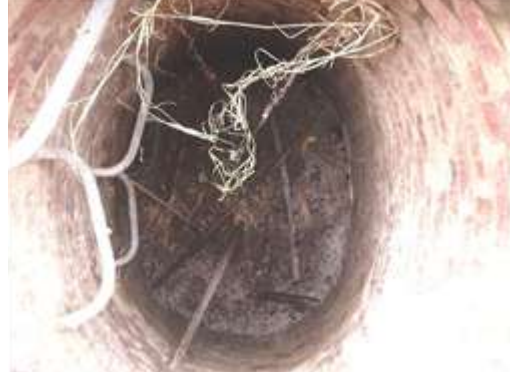
Top View

Channel debris.

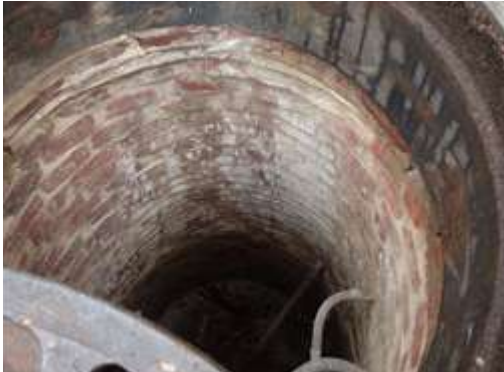
Defect

Frame leaks. Adjustment deterioration, root intrusion, loose brick and infiltration. Barrel infiltration - other side.

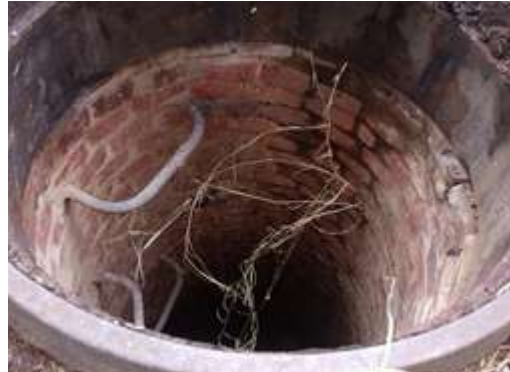
Defect

Frame leaks. Adjustment deterioration, root intrusion, loose brick and infiltration. Barrel infiltration.

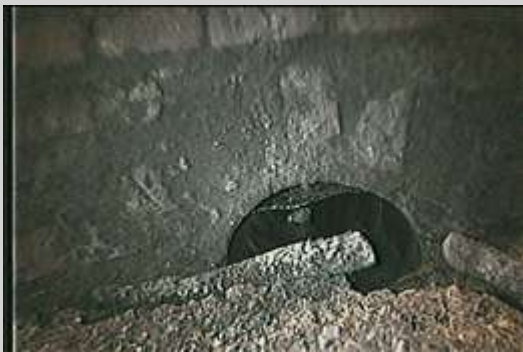
8 in. Circular Gravity Sewer
Pipe Out @ 12 O'Clock

Deposits: ☐ None ☒ **Mud** ☐ Sludge ☒ **Debris** ☐ Grease

Silt Depth: **1** (in.) Deposits Extent: **Light**
